DEMOLITION OF AN INDUSTRIAL BUILDING IN AN URBAN SITE

Case History: Panzani Ponte Liebig Spa Factory in Perugia, Italy

by Roberto Folchi

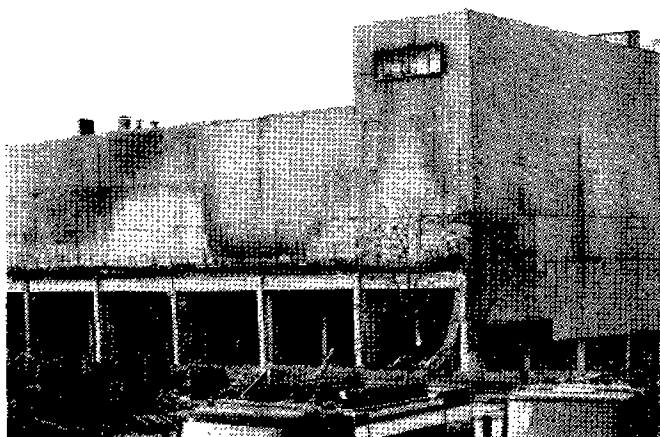
The springing area was about 1'700 m² and the height was 19 m (25M in the eastern side). The static condition of the structure appeared deeply compromised by the fire.

Several floors had caved in – no longer able to withstand the weight of machinery. Those floors left standing were severely bent and covered with wreckage.

The building "A" to be demolished (photo taken by spot "beta," see fig. 1)

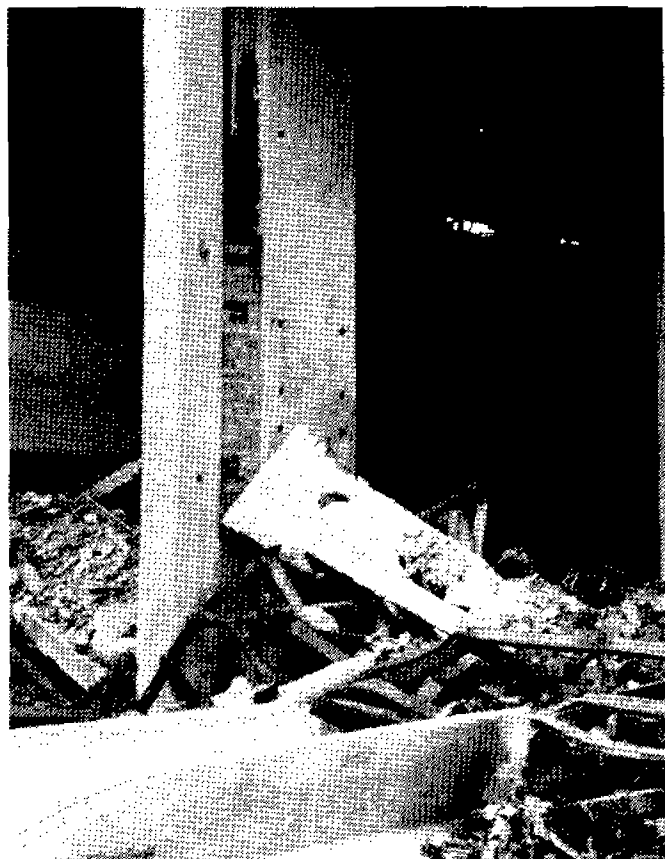
Explosives charges were placed in preexisting passing holes in the pilasters (hole diameter "Ø" was of 60 mm, photo 5). Drilling new holes was much too dangerous because of the structures critical stability.

Pilaster of the first and second rows. It is possible to see the preexisting passing holes that were charged with explosive cartridges. It is also possible to see a floor all covered with wreckage and machinery destroyed by the fire (photo taken by spot "gamma," see fig. 1).

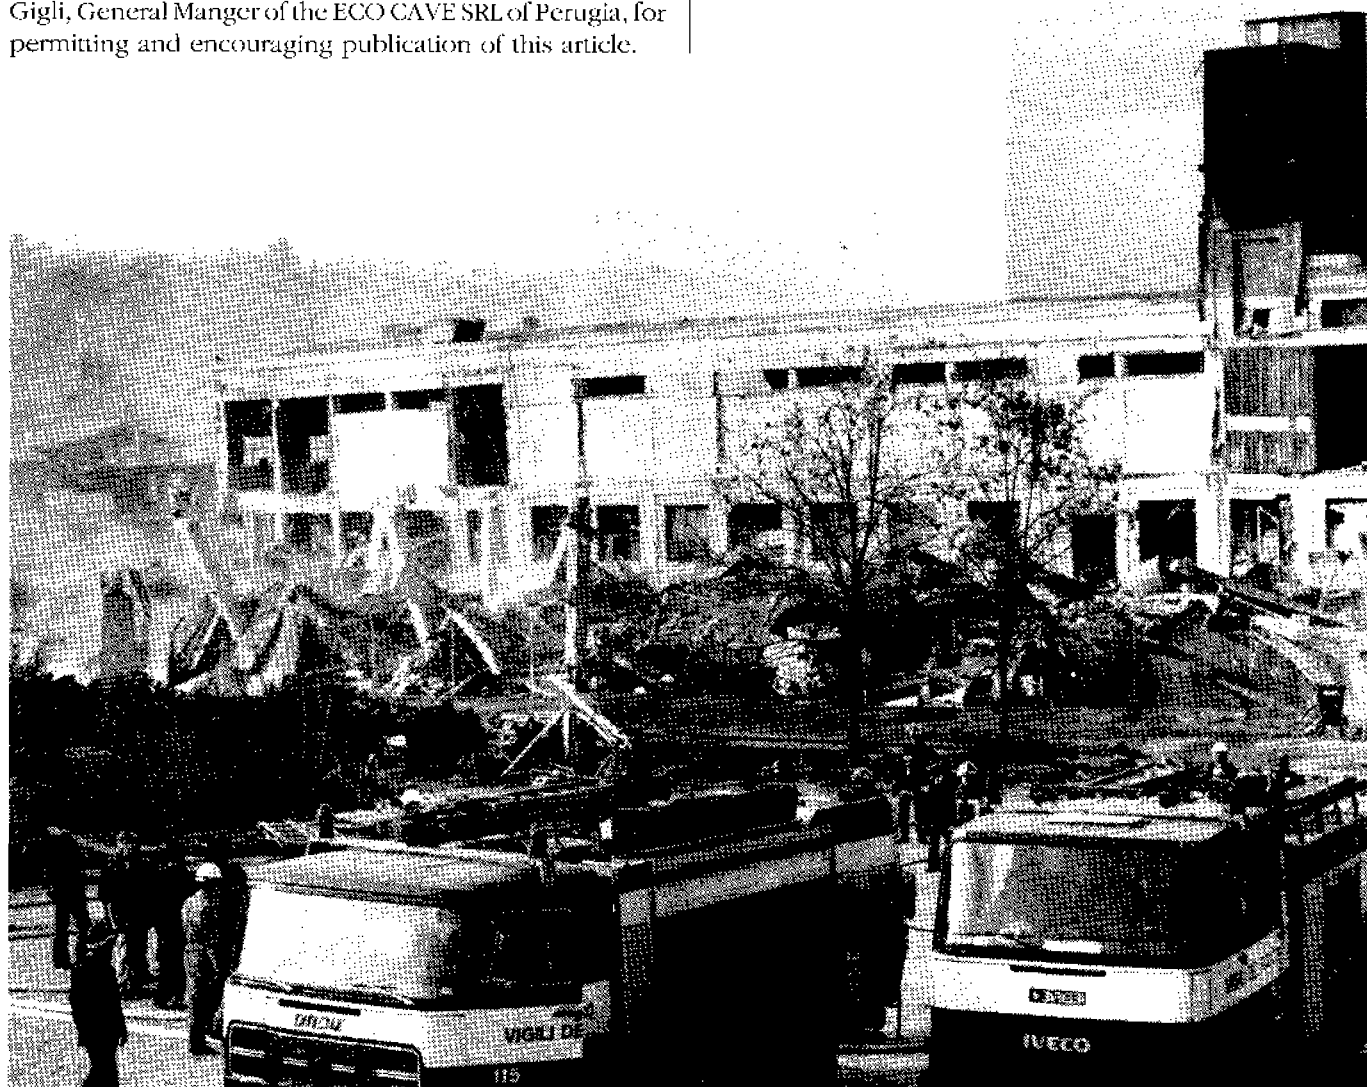
Structure collapsed on ground.
